Manhole Inspection Summary

Manhole # S2311_004MH

Insp Date: **7/23/08 3:22 PM**

Location Address: **2700 Ganey Dr**

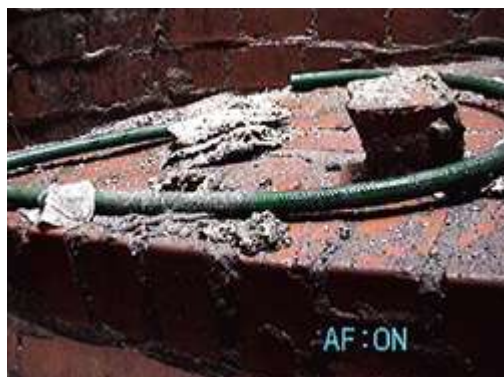
Misc

debris bench

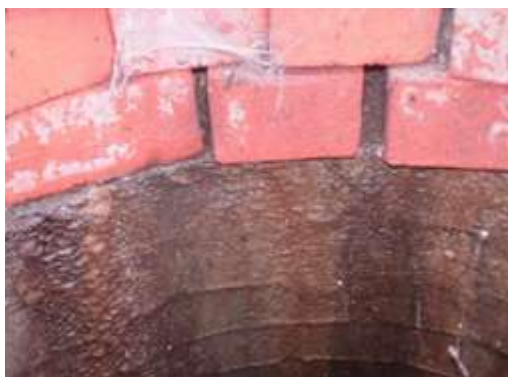
Defect 4

Infiltration: ☐ None ☒ **Joint** ☐ Cracks ☐ Mortar ☐ Roots ☒ **Wall**

corbel infiltration

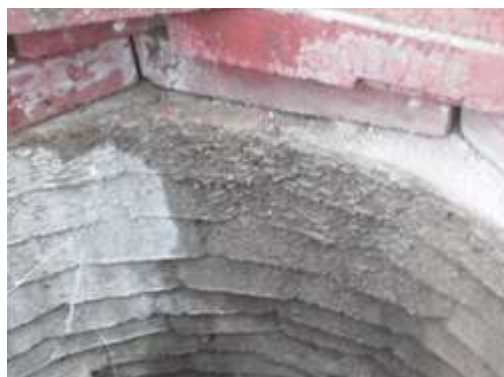
defect

infiltration chimney/corbel wall

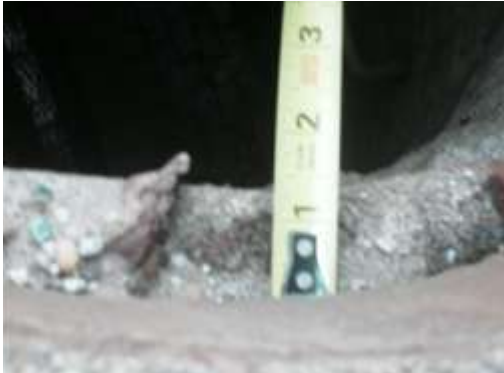
offset

Frame Offset: **1.5** (in.) Condition: ☐ Sound ☐ Cracked ☒ **Leaks**

1.5 inch

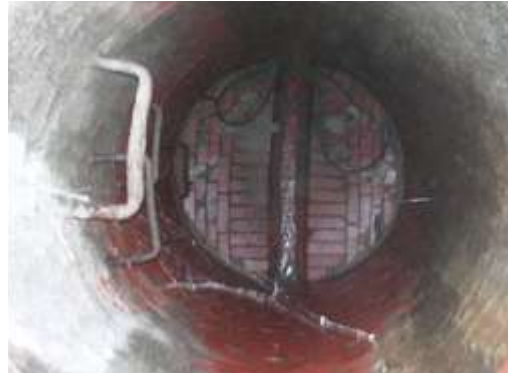
Defect

Steps Count: **5** Missing: **0** ☒ **Corroded**

steps corroded

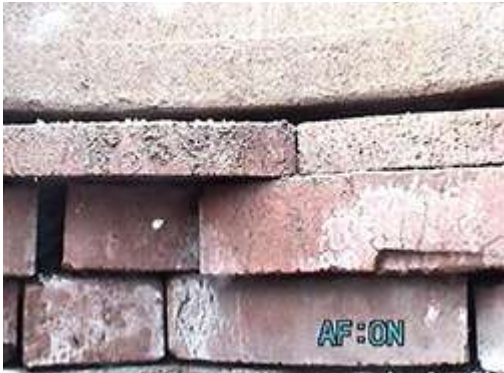
Defect 3

Condition: ☐ Sound ☐ Cracked ☐ Root Intrusion ☒ **Loose Brick** ☒ **Deteriorated**

chimney missing mortar/ loose bricks

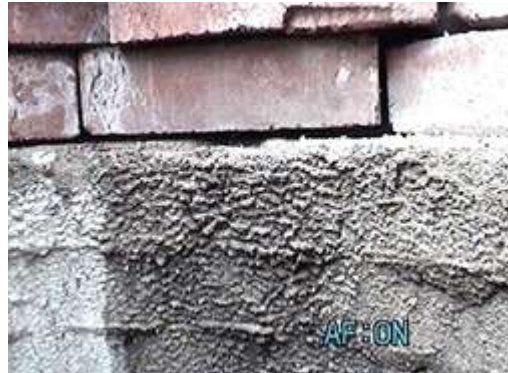
Defect 2

Infiltration: ☐ None ☒ **Joint** ☐ Cracks ☐ Mortar ☐ Roots ☐ Wall

chimney-joint corbel infiltration

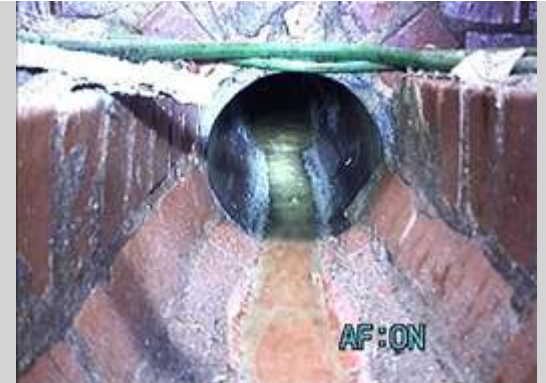
12 O'Clock Outflow

Pipe Height: **8.4** (in.) Rod and Bar (Angled)
Pipe Material: **Clay** ☐ Pipe Lined
Invert Depth: **11.26** (ft.) Flow Characteristics: **Fast**
Deposits: ☒ None ☐ Mud ☐ Sludge ☐ Debris ☐ Grease
Silt Depth: **0** (in.) Deposits Extent:
Infiltration: **None** Pipe Seal Cond: **Sound**

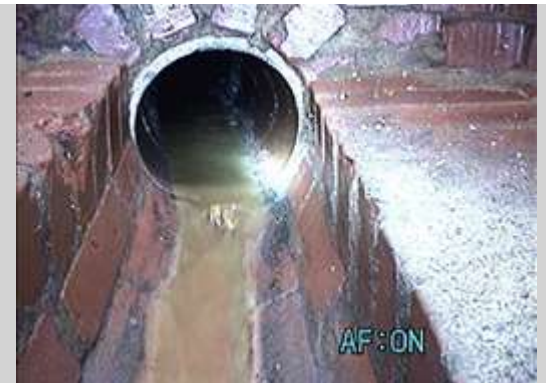
6 O'Clock Inflow

Pipe Height: **8.4** (in.) Rod and Bar (Angled)
Pipe Material: **Clay** ☐ Pipe Lined
Invert Depth: **10.82** (ft.) Flow Characteristics: **Fast**
Deposits: ☒ None ☐ Mud ☐ Sludge ☐ Debris ☐ Grease
Silt Depth: **0** (in.) Deposits Extent:
Infiltration: **None** Pipe Seal Cond: **Sound**
